Reference report St Stephen's Cathedral, Passau

Fire protection in St Stephen's Cathedral in Passau

New inspection opening closures meet historic building conservation

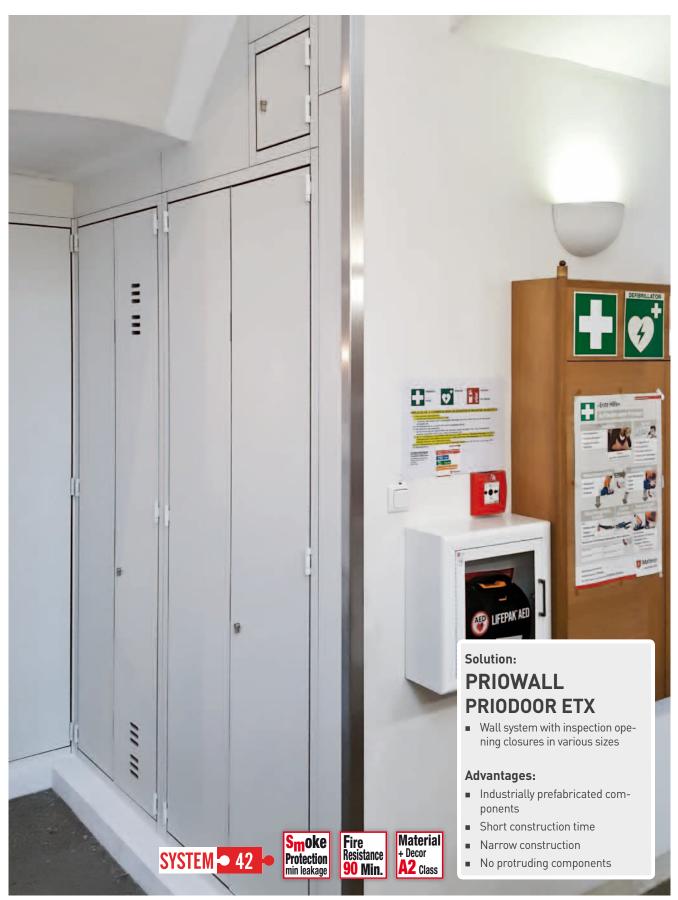
PRIOWALL wall system with various PRIODOOR ETX inspection opening closures

A wall system with integrated inspection openings was installed, the surface was

ready-coated to the customer's wishes. Fire resistance 90 minutes, hot and cold smoke-tight.

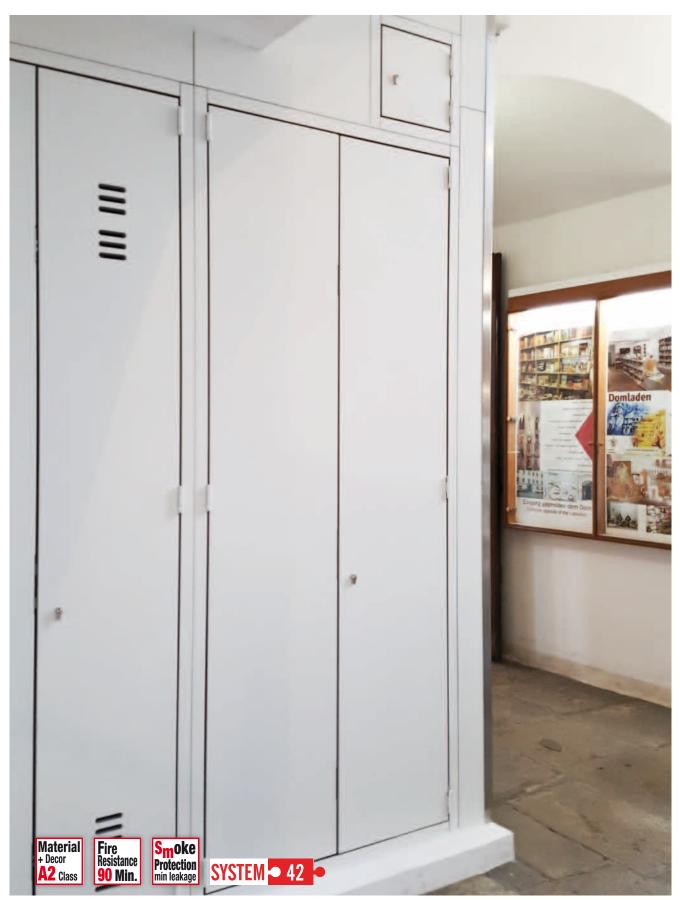
PRIOWALL wall system with various PRIODOOR ETX inspection opening closures

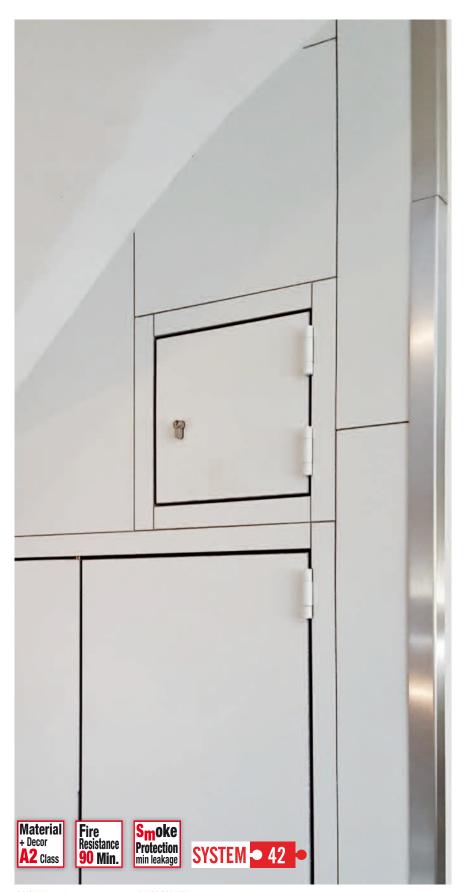
${\tt PRIOWALL\ wall\ system\ with\ various\ PRIODOOR\ ETX\ inspection\ opening\ closures}$

Project data	
Project location:	St. Stephan's Cathedral, Passau
Building:	Culture, monument protection, renovation
Year of construction:	2016
Solution:	Wall system PRIOWALL with inspection opening closures PRIODOOR ETX
Material:	Non-combustible panel with surface coating, classification A2 – s1, d0
Fire resistance:	90 minutes
Protection Target:	Fire load insulation of electrical systems in escape and rescue routes
Special features:	Surface white, similar to RAL 9016; inspection opening closures PRIODOOR ETX in various sizes, ventilation system in door leaf
